## COASTAL DEVELOPMENT PERMIT APPLICATION

**Application number** .....3-04-030, Pebble Beach Golf Links, 5<sup>th</sup> Tee and 5<sup>th</sup> Green Seawalls

**Project location** .....Pebble Beach Golf Links 5<sup>th</sup> Hole, Pebble Beach (Monterey County).

**Exhibit F – pg 1 of 4**  
Staff photos of 5<sup>th</sup> Tee and 5<sup>th</sup> Green (dated October 27, 2004)

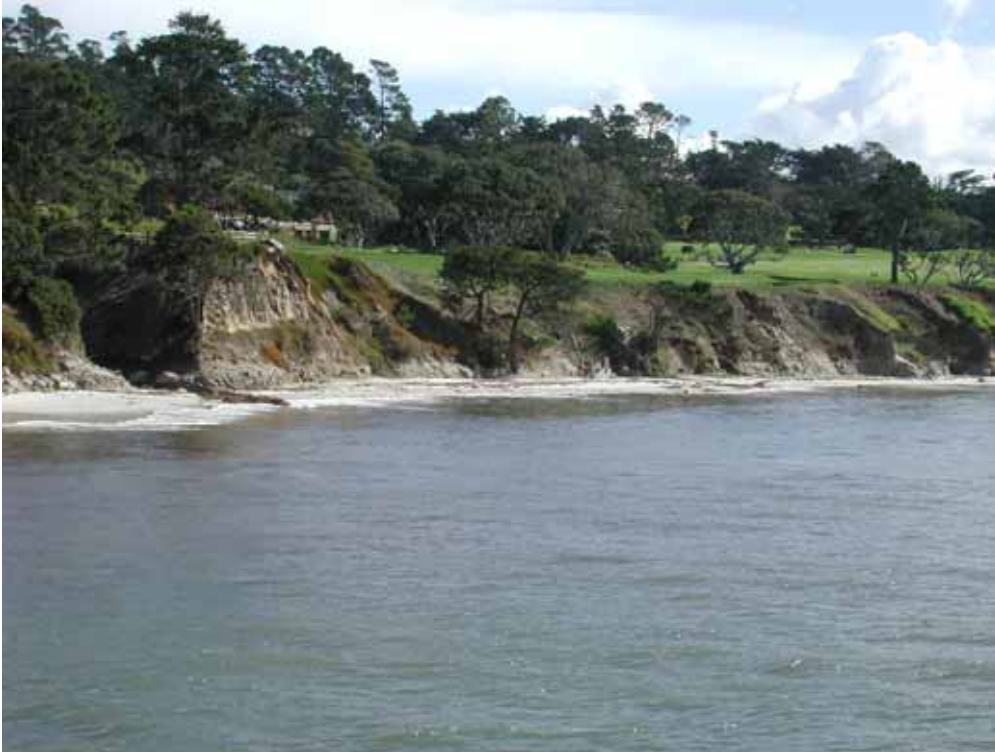
Photo 1.  
Staff photo of 5<sup>th</sup>  
Tee and fairway -  
ravine, main tee  
and upper tee on  
left of photo.

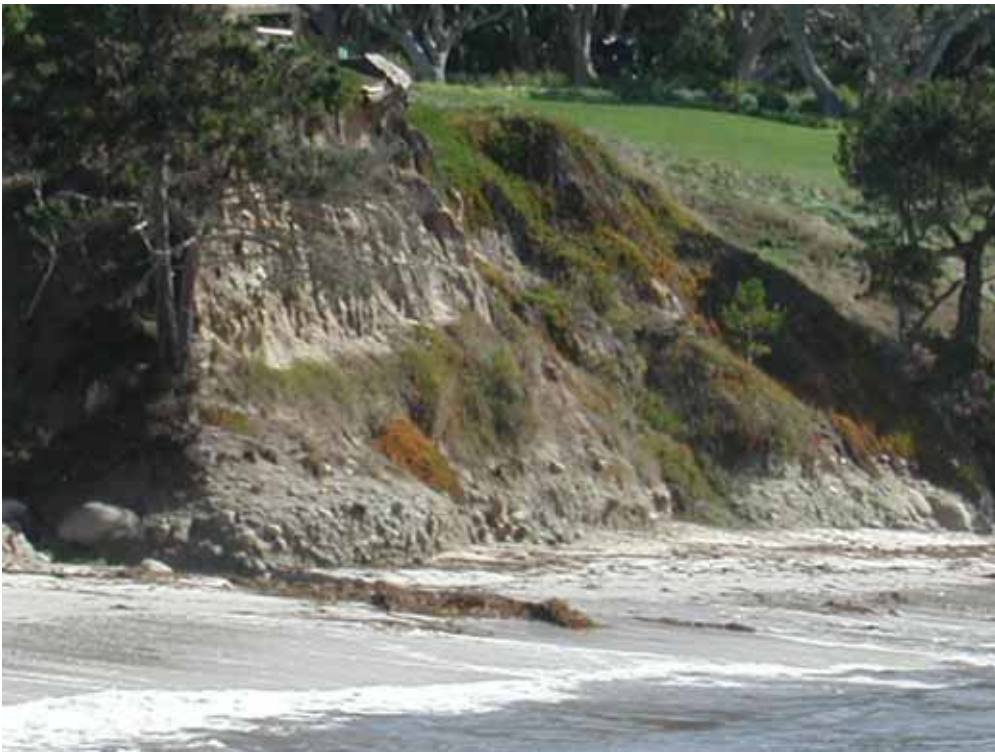
At the 5<sup>th</sup> tee complex, terrace deposits overlie the bedrock with an average slope inclination of about 55 degrees. Due to wave erosion at the toe, the bluff face at the 5<sup>th</sup> tee complex is over-steepened. As the toe of the bluff is eroded the bluff top recedes. At the 5<sup>th</sup> green complex, the bedrock face is near vertical with terrace deposits above sloping at about an average gradient of 35 degrees. Perched groundwater has also been observed above the bedrock contact, saturating the terrace deposits from an elevation of about 11 feet MSL up to about 18 feet MSL. Groundwater levels may fluctuate due to variations in rainfall and other factors.

Photo 2.  
Staff photo bluff  
below 5<sup>th</sup> tee.

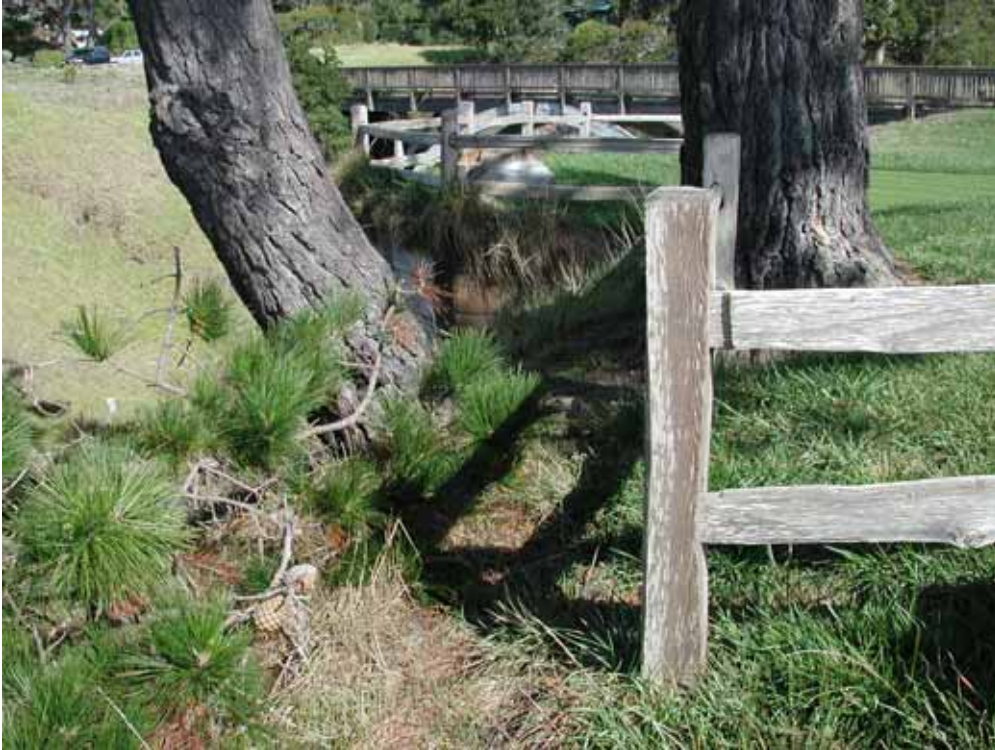
Photo 3.  
Staff photo of 5<sup>th</sup>  
Tee – showing tee  
box retaining wall  
along ravine and  
edge of bluff at  
undercut tree near  
upper tee.

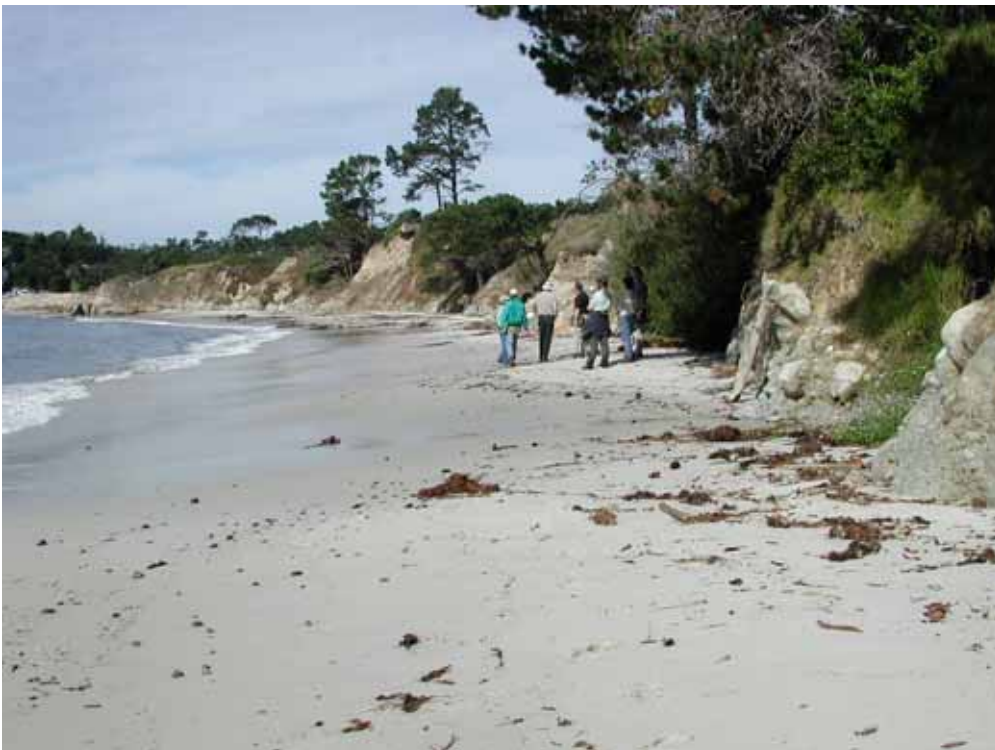
Photo 4.  
Staff photo of bluff  
below 5<sup>th</sup> hole -  
showing undercut  
area near 5<sup>th</sup> tee.

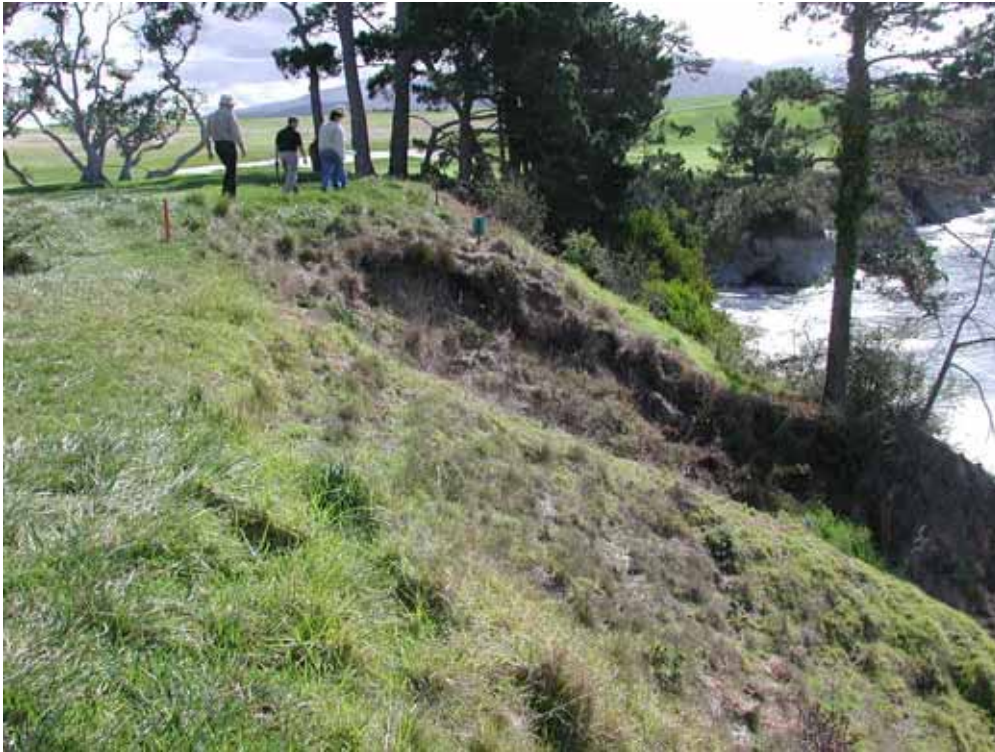
the HKA 5/04 report, the landslide at the 5<sup>th</sup> green occurred in an area where the bedrock is fractured and so more susceptible to erosion than other non-fractured areas of bedrock; they also noted that this area is one of the areas that is eroding most quickly. Based on measurements taken from project plans, the top of the bluff near the 5<sup>th</sup> green is about 8 feet from the erosional gulley created by the 2004 landslide and within about 5 feet of the upper scarp of a smaller, more recent surficial slide (see photos in Exhibit F). Bunkers that surround the green are also within about 5 feet of the top of the bluff.

Photo 5.  
Staff photo of  
landslide scarp  
and erosional gully  
near 5<sup>th</sup> green –  
bunker to left.

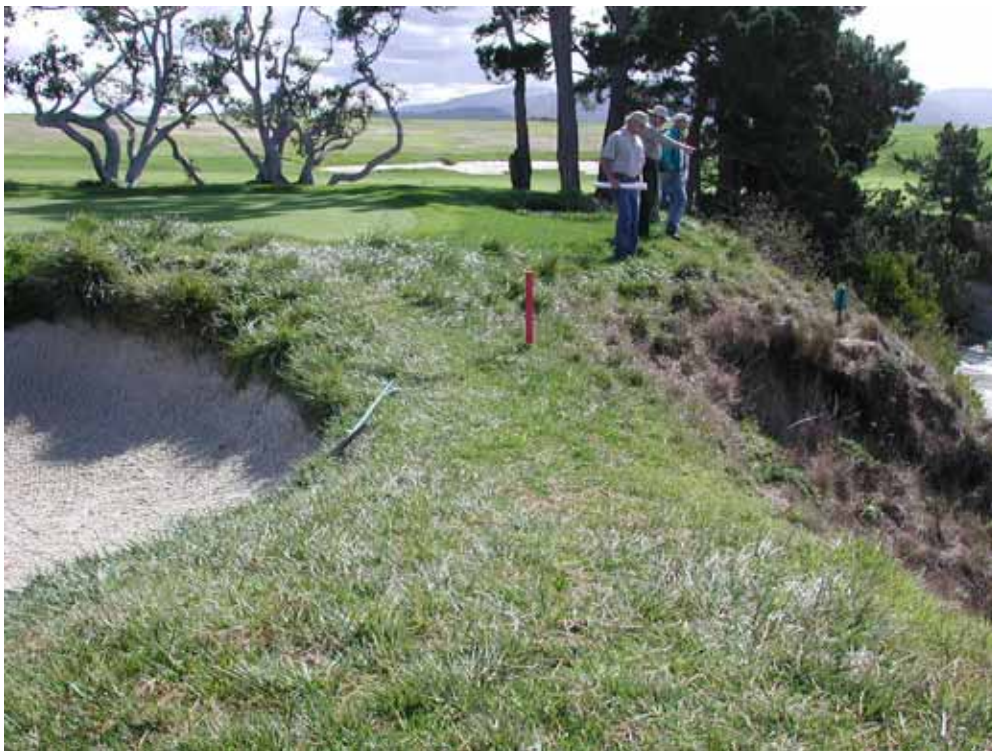
Photo 6.  
Staff photo of  
proximity of  
sandtrap and 5<sup>th</sup>  
green 5<sup>th</sup> to top of  
landslide scarp

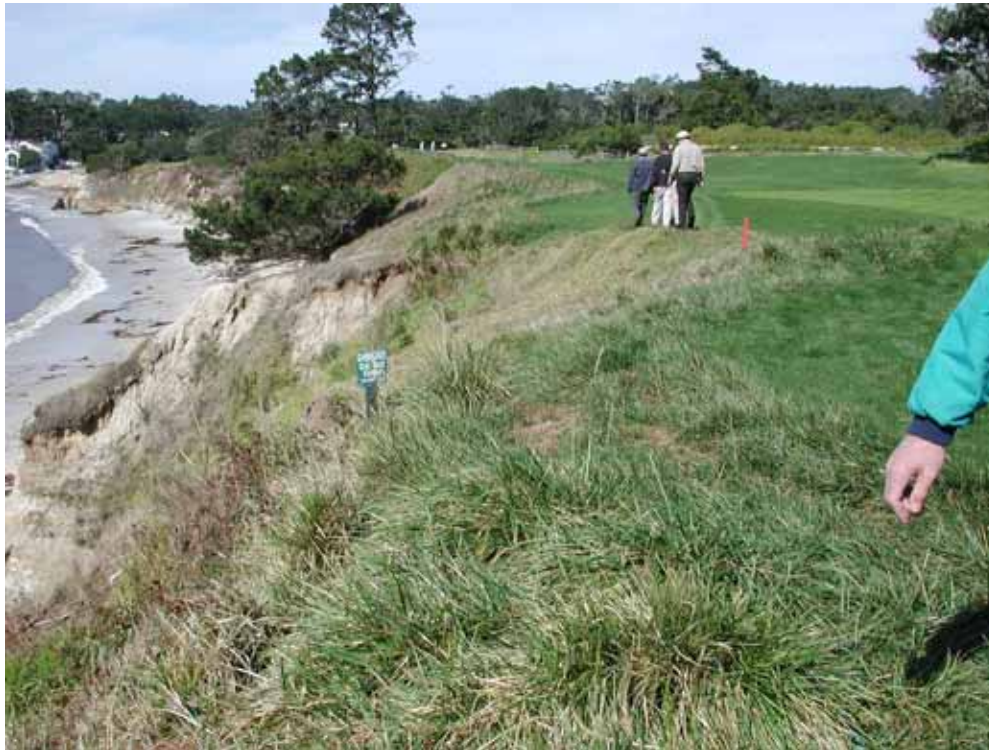
Photo 7.  
Staff photo looking  
north from 5<sup>th</sup>  
green showing  
proximity of hole  
to top of bluff.

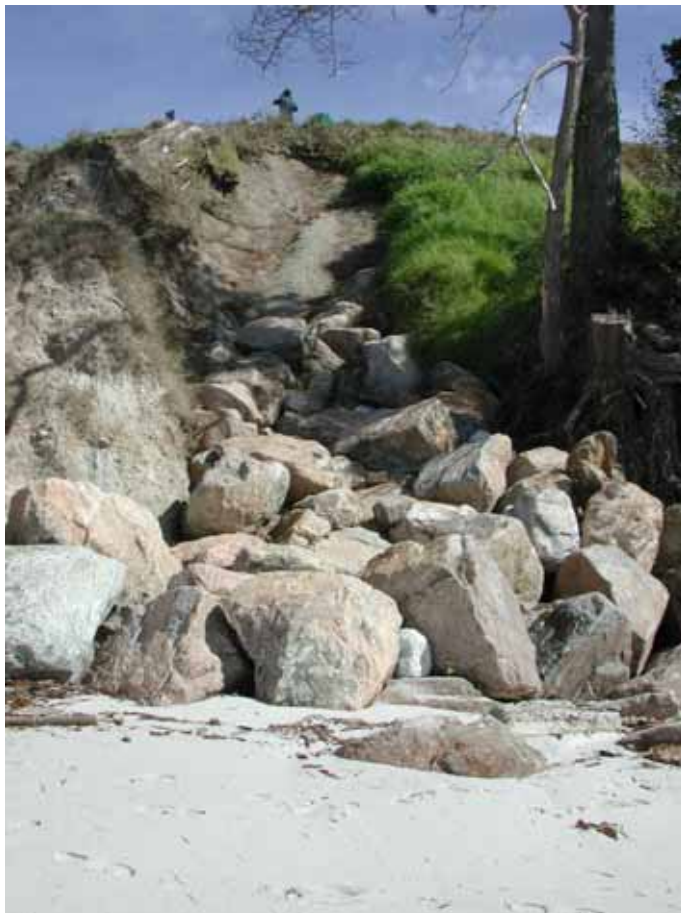
Photo 8.  
Staff photo of  
emergency  
rebetment and  
shotcrete in  
erosional gully  
formed by  
landslide below  
5<sup>th</sup> green.
